Slope stability problems in Denmark - a joke or dire reality?

J.S. Steenfelt,
COWI A/S, Kongens Lyngby, Denmark; jos@cowi.dk

ABSTRACT: Contrary to common belief, even Denmark suffers slope failures in natural and man-made slopes. In a majority of the failures water is the catalyst combined with oversight or neglect of fundamental soil mechanics principles. The paper describes three cases of slope failures, two natural and one man-made, and the subsequent forensic geotechnical engineering investigations and remediation.

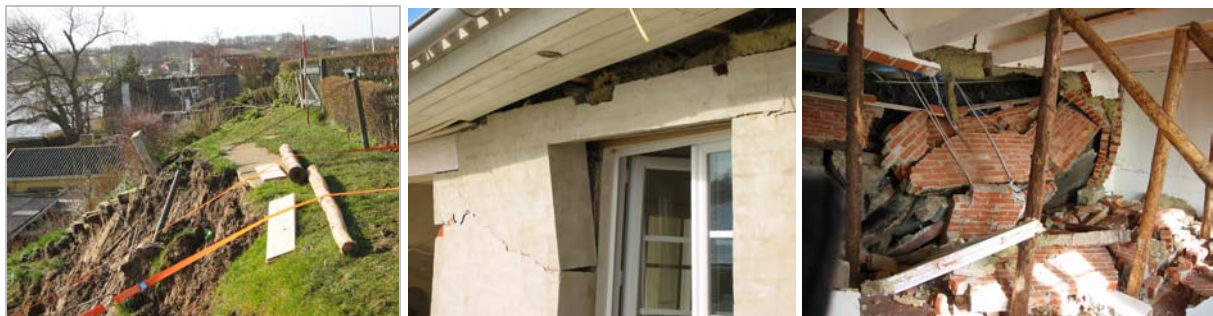
The case histories amply demonstrate that our capabilities in terms of testing do not always meet our expectations. But back-calculation based on well-winnowed experience proved to be invaluable, hence re-iterating the need for case histories in geotechnical engineering. Even smaller slope failures carry loud messages as seen from Figure 1.

Figure 1. Dire reality of a minor slope failure leading to total demolition of a one-family house in Denmark

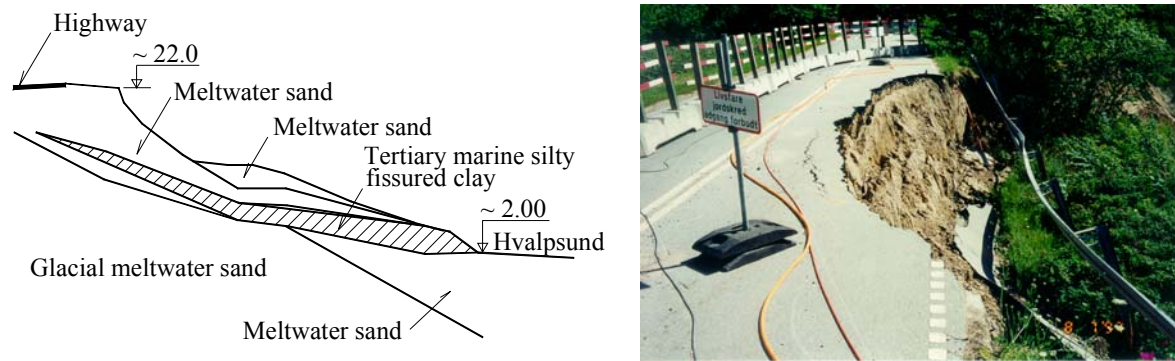
The Sundsøre site is situated in north-eastern Jutland where Highway 472 runs parallel to the top of a 21 m high slope towards Hvalpsund cove. Over a period of eight years, prior to the failure in 1995, a series of smaller failures had taken place. As a result the distance from the highway to the crown of the slope was down to six metres. The Road Authorities had therefore instigated a review of the stability of the slope.

Figure 2. (a) Cross section at slope at Sundsøre prior to failure; (b) Second failure involving half the highway

Geotechnical borings in the slope revealed rather complicated slope geology. One boring at the crown showed 1.0 m of leached, glacial clay till above 6.5 m of glacial meltwater sand with grain sizes and gravel contents increasing with depth. This was underlain by some 2 m thick wedge of Tertiary, marine silty fissured clay. Below the Tertiary clay, glacial fine to coarse meltwater sand was found to a depth of 14.5 m below the crown. The borings carried out down the slope confirmed the presence of a floe of Tertiary clay, wedged at an angle along and across the slope profile. A cross section of the slope appears from Figure 2.

Based on the site investigation and a preliminary assessment of strength parameters and ground water conditions it was found that the factor of safety for the slope was below the requirements of the Danish Code DS 415 (1984). For safety reasons half the highway was therefore blocked pending remediation work on the slope.

A solution involving a decrease of slope angle was not considered feasible, and hence the road authorities decided to permanently change the alignment of the road away from the slope. The wisdom of the decision was borne out by a new slope failure taking place shortly after the decision and without warning. Half the highway disappeared over a length of about 100 m (cf. Figure 2b).

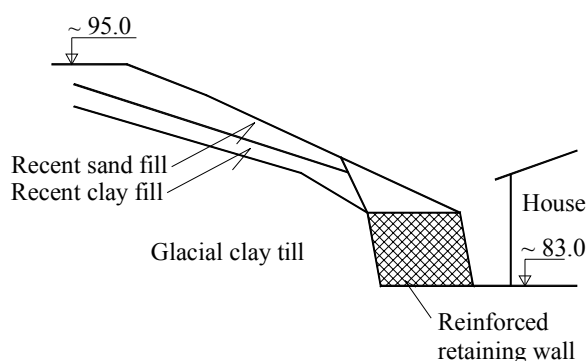
The slope at the residential area "Høgsholtparken" is situated in the northern part of Vejle in eastern Jutland. The slope was about 12-15 m high and to accommodate a series of new domestic houses, up to 16 m of the slope was removed at the bottom of the slope (cf. Figure 3a).

The forensic investigation with geotechnical borings carried out in the slope showed recent sand and clay fill deposits (or solifluction deposits) to a depth of some 1-3 m below the surface. This was underlain by rather plastic glacial clay till to a depth of 12 m below the surface. Glacially, fine to medium meltwater sand was found 12 to 15 m below ground surface (end of borings). The clay till deposit was interlaced with thin horizons of medium to coarse sand till. The primary groundwater table was found to be well under the level of the foot of the slope. A cross section with interpreted soil boundaries is shown in Figure 3a.

Figure 3. (a) Interpreted soil boundaries for slope at "Høgsholtparken"; (b) Damage from the slope failure

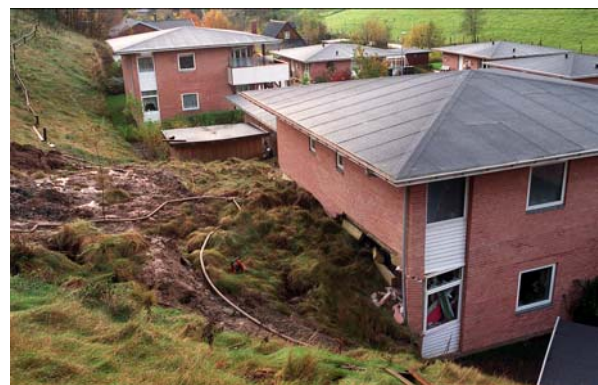
The slope could not be cut back due to a series of existing apartment buildings close to the crown of the slope. Hence, an up to five m high reinforced sand retaining wall was established at the base of the slope with the new houses as close as 2 m away. However, the reinforced slope was not stable, and over a period of time a series of smaller slope failures took place up to October 1998, where the gable on one of the houses collapsed due to a major, sudden slide (fortunately without any bodily harm to the inhabitants), as seen in Figure 3b.

The reason for the failure was clearly a build-up of pore pressure during heavy rainfalls in the interface between the top deposits (of sandy, gravelly, fill and clay) and the underlying clay till in combination with an inadequate soil reinforced retaining wall at the foot of the slope.

Due to the limitations imposed by the existing building at both the top and the foot of the slope, it was not possible to reduce the slope angle per se. Instead two different solutions were tendered:

- A traditional Danish solution with a tied back sheet pile wall at the top of the slope (retaining the crown of the slope) allowing a reduction of slope angle
- Soil nailing of the existing slope maintaining the slope angle. This solution invites itself, as the very competent clay till is at shallow depth

Although the soil nailing solution was technically feasible the (Danish) traditional solution, with a sheet pile wall at the top, was preferred as this allowed a transparent pricing of the remediation works.
